ERDC/EL SR-00-11

## **Status of Waterhyacinth/Hydrilla Infestations and Associated Biological Control Agents in Lower Rio Grande Valley Cooperating Irrigation Districts**

September 2000

Final report

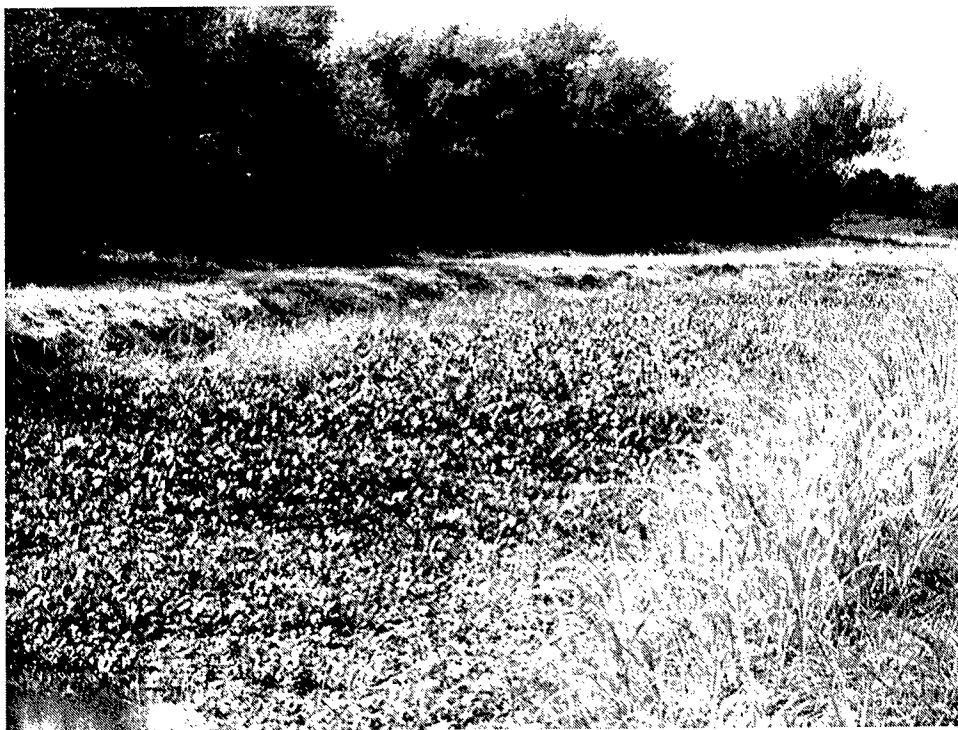
Figure 14. Canal leading away from the Cameron County Irrigation District No. 6 Pumping Station. Note the large waterhyacinth infestation completely covering the canal. While some areas of the canal were open, a majority was completely covered. The waterhyacinth at this site was very healthy with only minimal damage from biological control agents. Limited encroachment by other plant species was observed at this site

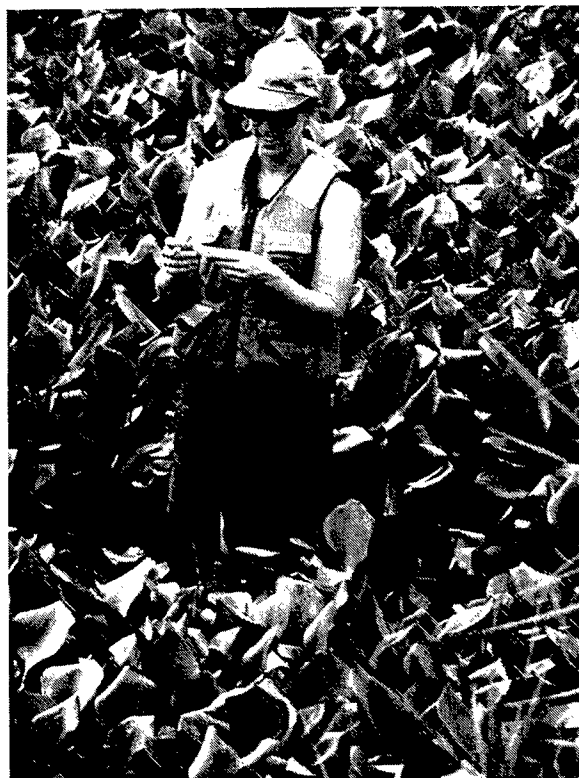
Figure 15. Close-up view of canal at Cameron County Irrigation District No. 6. Note healthy plants with only limited feeding damage by *Neochetina* spp.

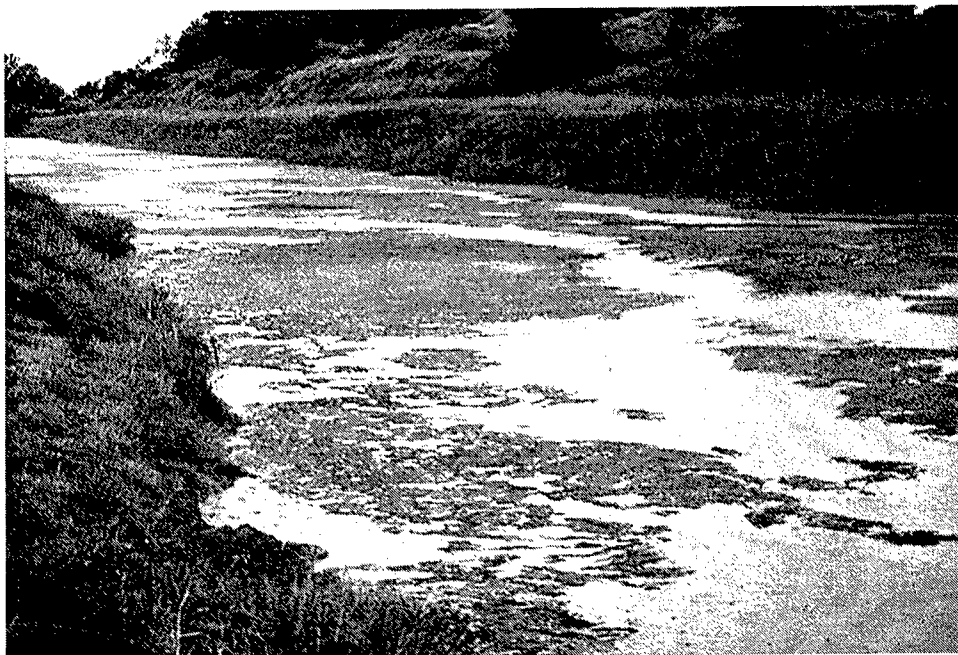
Figure 17. Canal leading from the Rio Grande to the Harlingen Irrigation District (Cameron County) No. 1 Pumping Station. Minimal waterhyacinth was present at this site and most of the plants appeared stressed. While an extensive hydrilla infestation appears present, closer inspection revealed it was mainly algae covering what had probably been an infestation. Reasons for the hydrilla disappearance are unknown

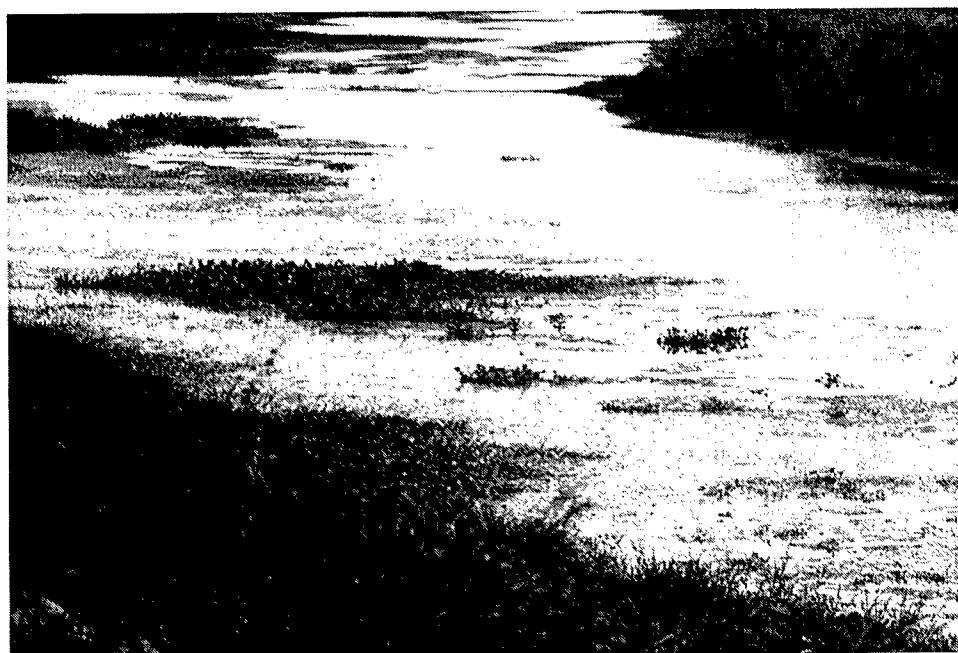
Figure 18. Canal leading from the Rio Grande to the pumping station of Cameron County Irrigation District No. 2. Similar to the Harlingen Irrigation District Cameron County No. 1 Canal (Figure 17), the waterhyacinth was highly stressed and the hydrilla infestation was minimal and mainly covered with copious quantities of algae

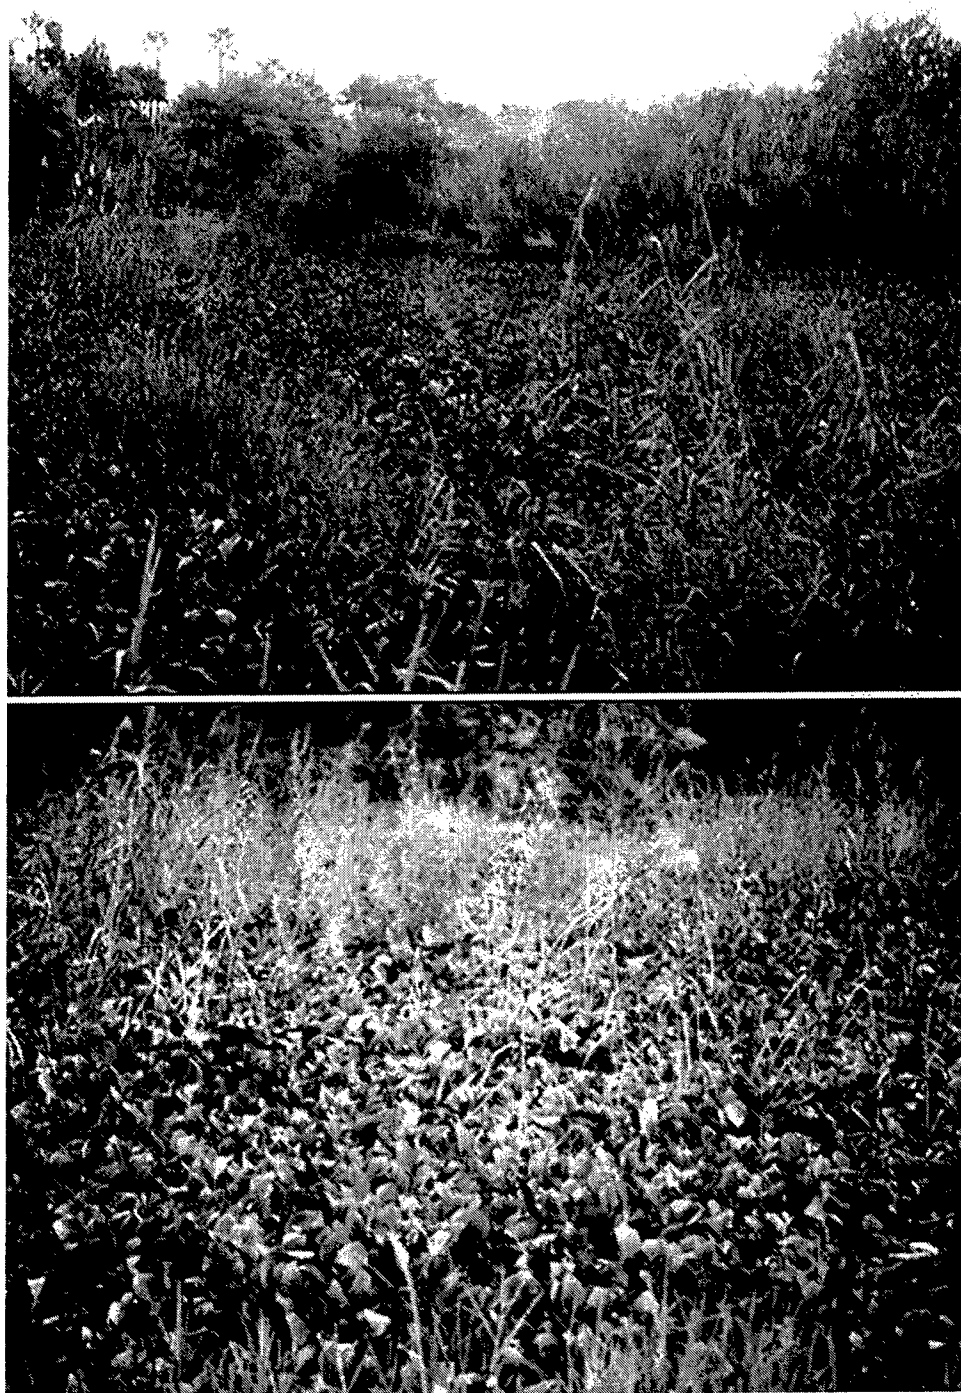
Figure 19. Composite view of an extensive waterhyacinth infestation on the Rio Grande adjacent to the River Bend Golf Course. While the waterhyacinth completely choked the river at this point (top), the plants appeared highly stressed by the feeding action of the insects and in numerous areas large populations of other plant species were observed encroaching into the mat (top, bottom). The plant species most commonly seen within the mat was another introduced species, *Arundo donax* (giant reed), which was commonly observed along large stretches of bank

River Bend Golf Course (Figure 19)	Site was located directly on river adjacent to golf course. Mechanical control of waterhyacinth and hydrilla had been accomplished at this site in prior years.	Large infestation of waterhyacinth was present and completely choked the river. Plants appeared highly stressed with limited flowering. Encroachment into the mat by other plant species, mainly <i>Arundo donax</i> , was observed.
